# Waste Audit Report

Zero Waste Tower, a 37-story mixed-use skyscraper in Anytown, USA, is a prime example of sustainable urban development. It offers some of the most spectacular views in the city, and its facilities include approximately 500,000 square feet of Class A office space, a street-level restaurant, a public plaza, 215 rooms in the city's first four-star hotel, and 28 luxury private residences on the top floors.

To analyze a normal collection cycle for the building, Waste2Zero conducted a waste audit of one day's waste collected on December 1, 2023. The audit included all waste from building occupants and visitors and represented 100% of the waste collected by the building's janitorial staff during a 24-hour period of occupied floors. Hotel waste was weighed as unique floors from office waste on the same level, for greater detailed reporting. Private Residence floors have single trash chutes connecting all such floors, so can only be measured as a single 'floor block' in the data set.

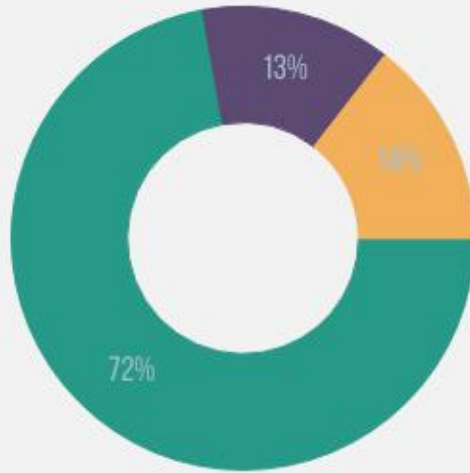
## BUILDING WASTE BREAKDOWN

- TOTAL DIVERSION STREAM: 72%
- TOTAL POTENTIAL DIVERSION: 13%
- TOTAL RESIDUAL 14%

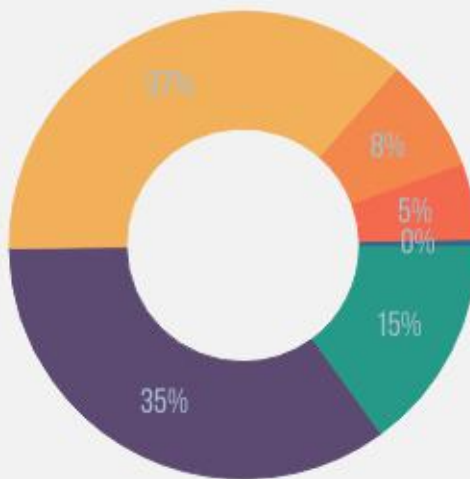
## BUILDING DIVERSION BREAKDOWN

- MIXED PAPER 15%
- CARDBOARD 35%
- GLASS 37%
- PLASTIC 8%
- METAL 5%
- E-WASTE 0%

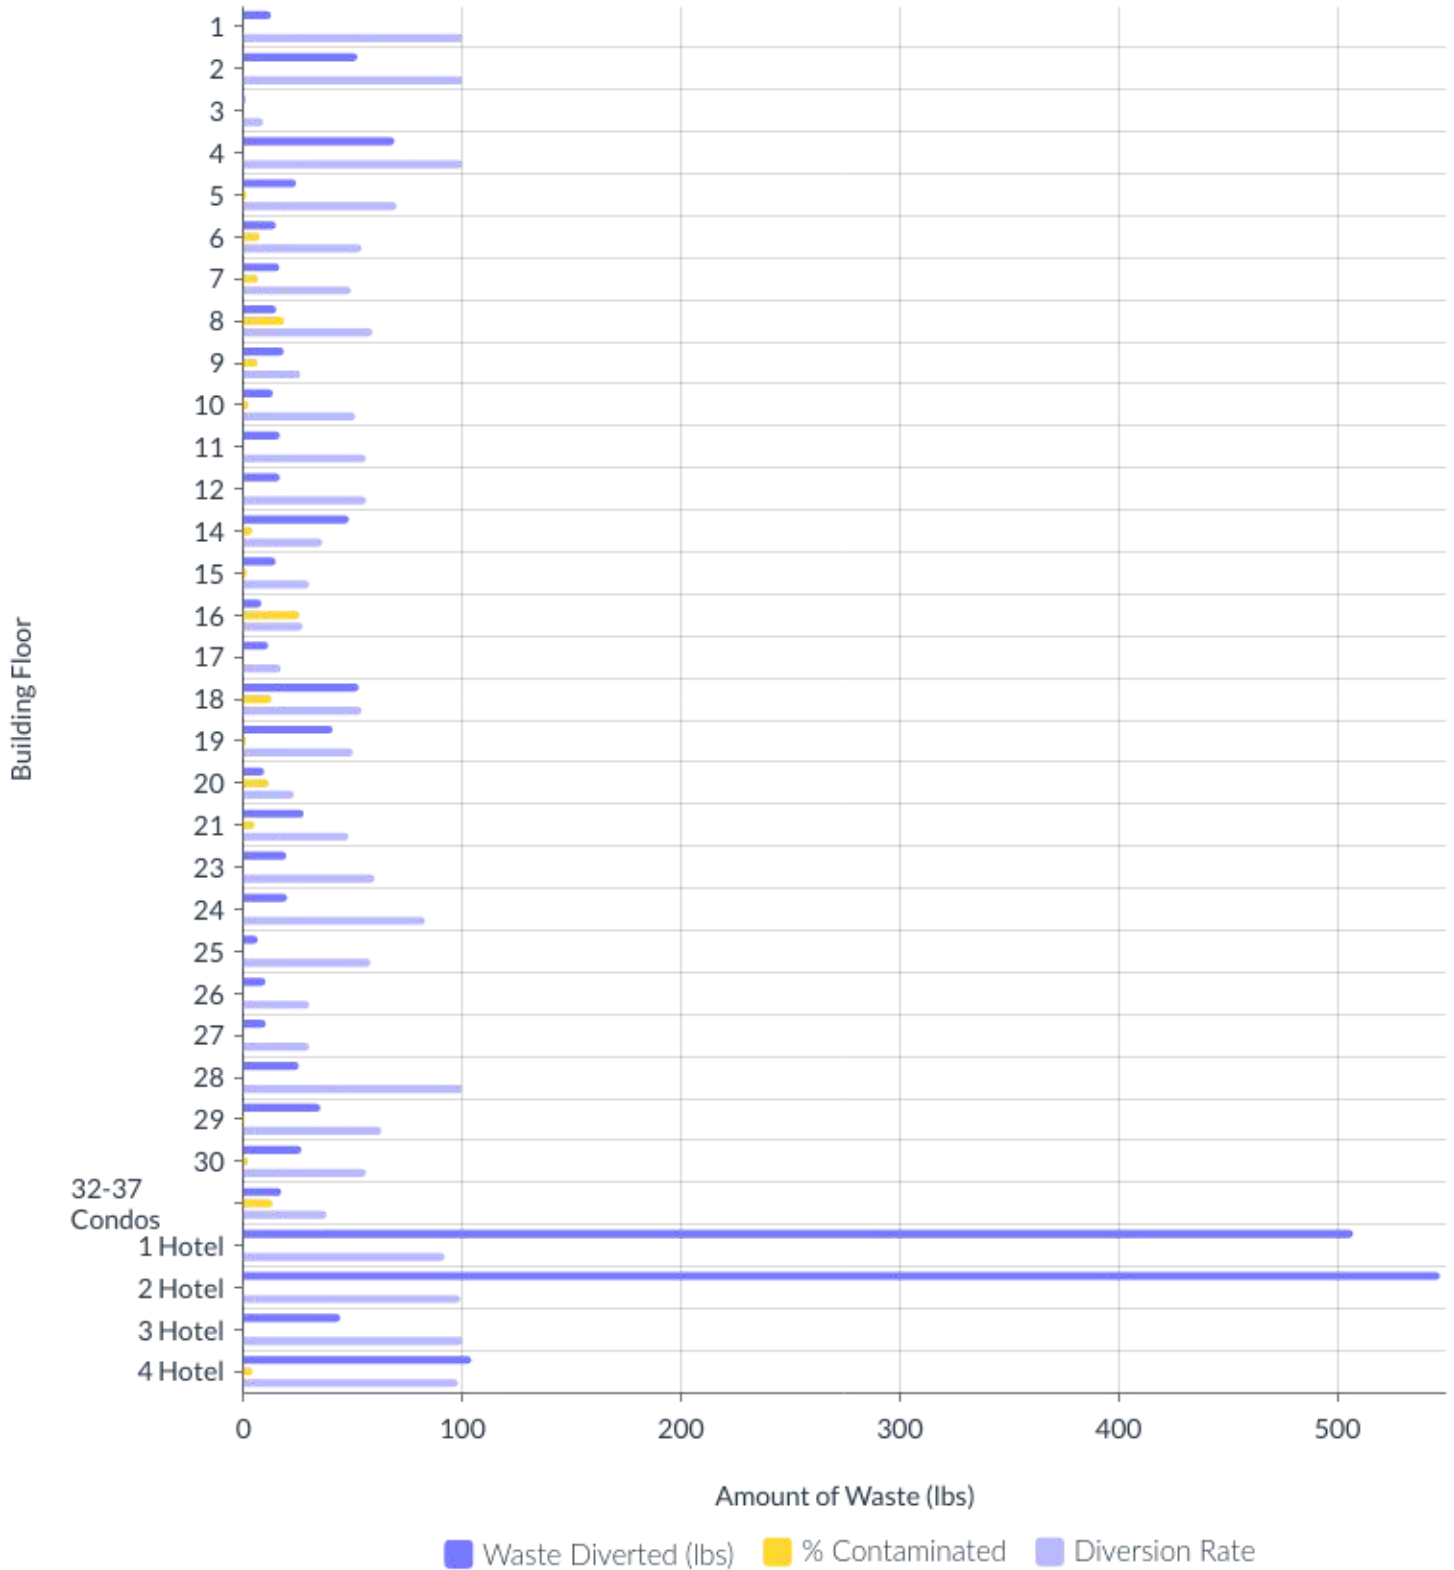
## Floor Comparison (Diversion & Contamination)

This is where we show each occupied Floor's diversion and contamination levels. This graph shows how much went to recycling, and how much trash or contamination was found in that recycling.

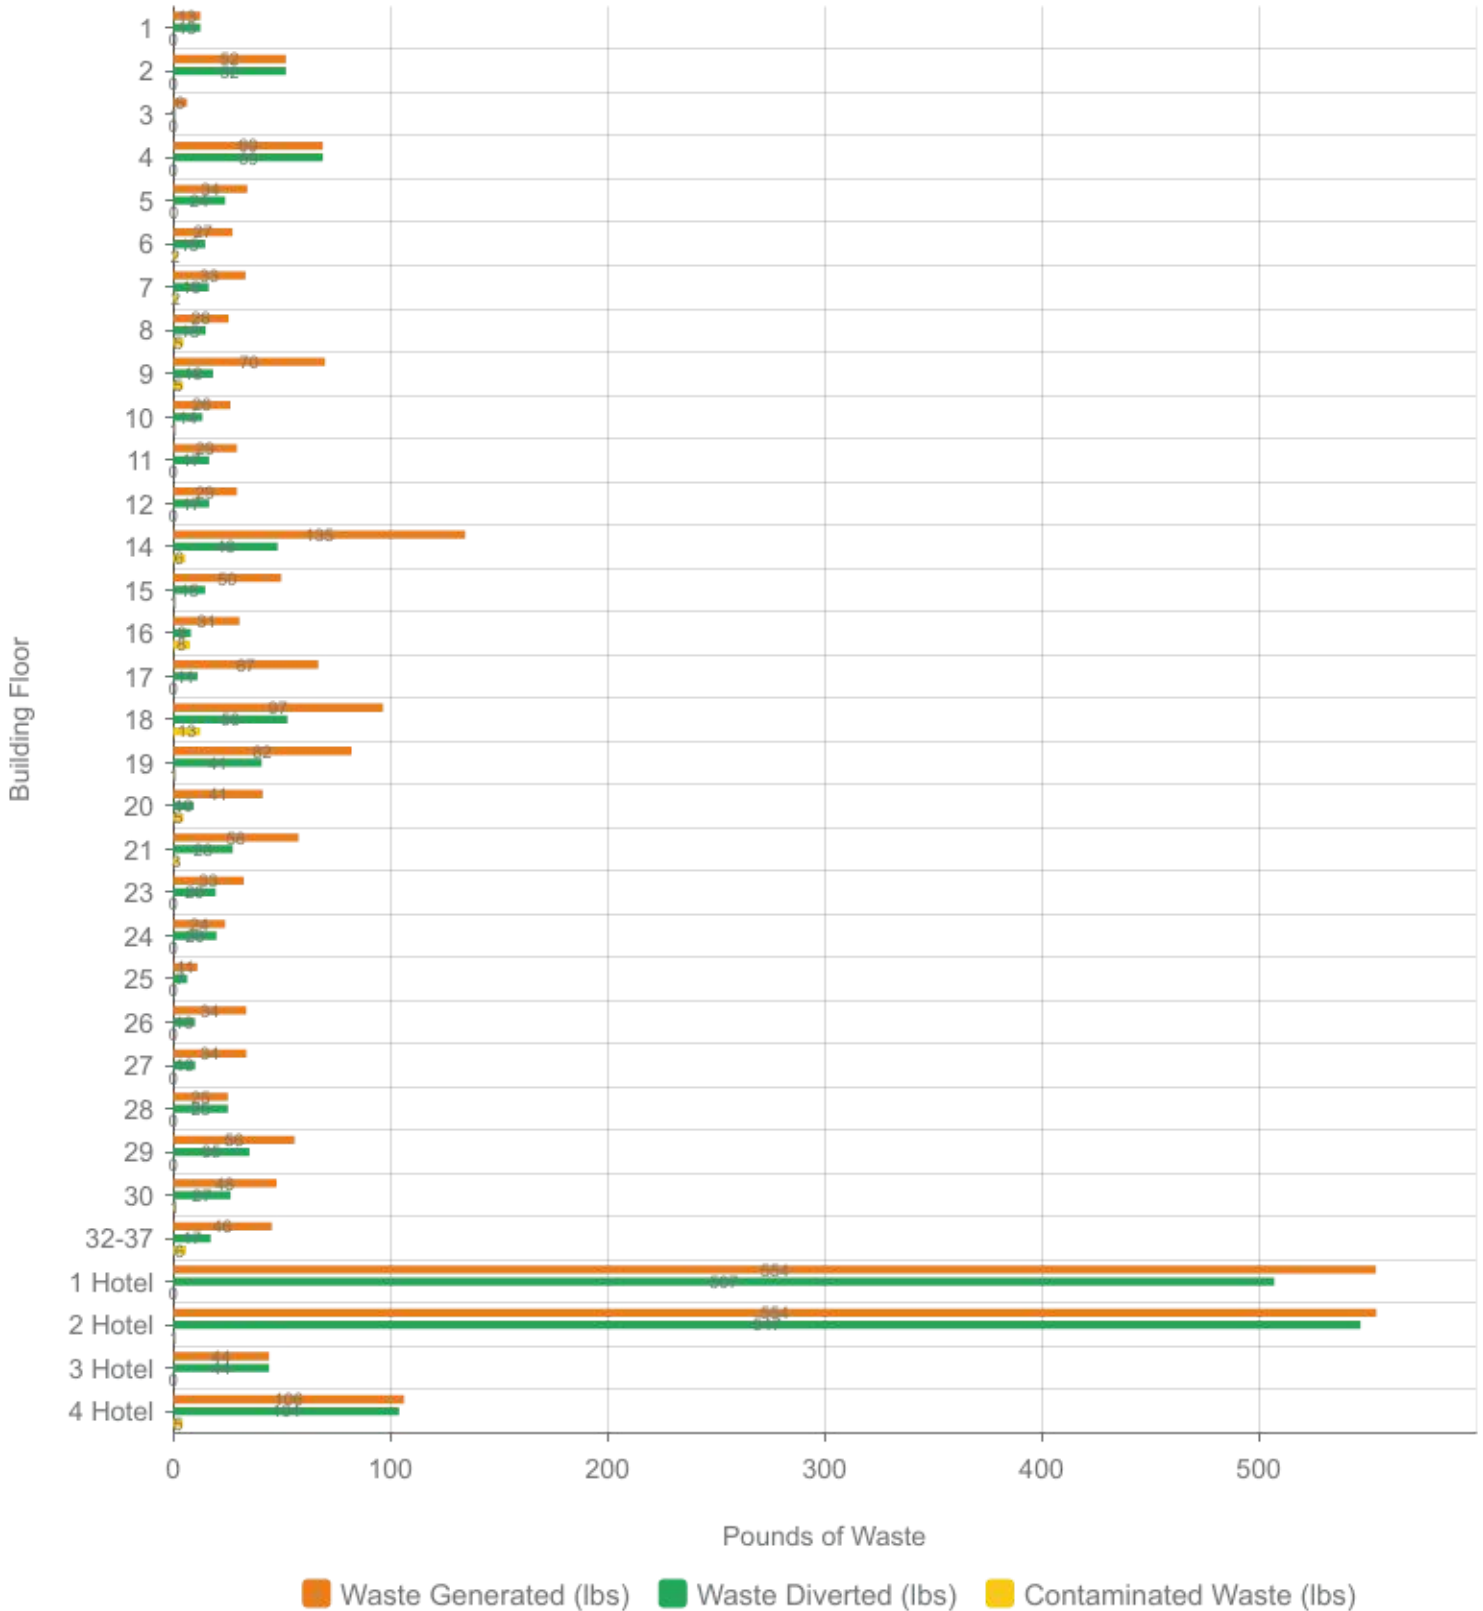
### Floor Comparison (Weight & Contamination)

This is where we show each occupied floor's waste and recycling volume by weight. This graph also shows how much trash was found in the recyclables stream and the volume diverted.

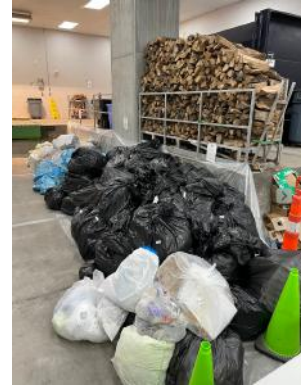
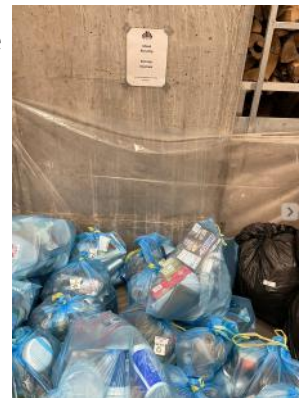
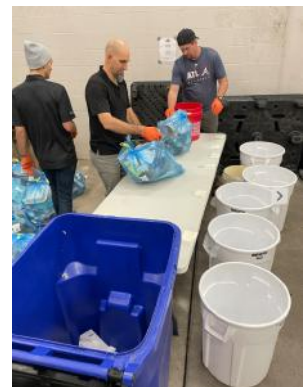
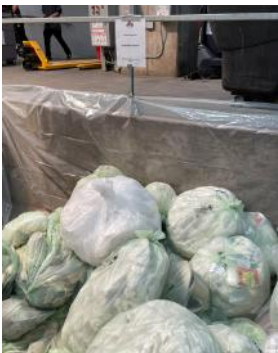
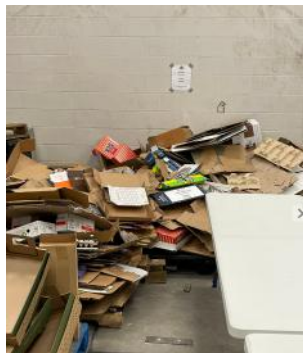
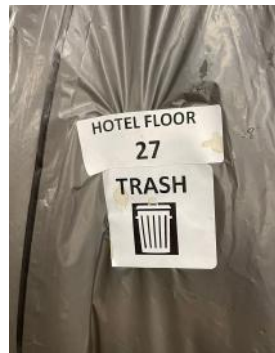
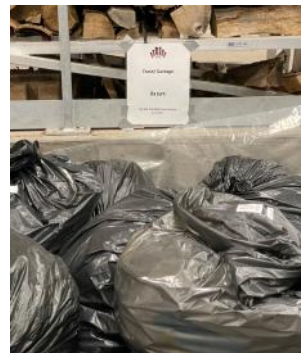
# A Closer Look: Audit Findings & Processes

- **Notably, Floors 3, 9, 16, 17 & 20 had diversion rates below 30%, setting them apart from all the Hotel Floors and floors 1, 2, 4 & 28, which all had diversion rates over 90%. These floors will be key points of focus for improving the success of Zero Waste Tower's overall program.**

- Likewise, Residential floors diverted only 38% of their waste, and had a rather high rate of contamination of their recyclables. This indicates **signage for residents may be lacking in clarity** or that there remain significant opportunities to invite tenants into experiencing the prestige and honor each floor could experience by setting itself apart with more competent recycling successes. **For luxury residential units, prestige and charitable impact can often be successful motivational strategies. It may be beneficial to arrange a competition during Earth Month for residential floors,** awarding tenants of the floor with the highest clean diversion rate a special recognition plaque (like an HOA might for the most beautiful garden, but in the lobby or even by changing their floor's elevator button to an emerald one for the year) along with a donation made in the residents' honor to a charitable cause of their choosing.

- Other notable considerations from the audit were that nearly 6 pounds of batteries appeared in the waste and recycling bins on floors 16 & 20, an extraordinary amount considering it was nearly all small disposable batteries (enough almost to fill a 5 gallon bucket!) **It is advisable to engage those 2 floors in additional conversation and signage that will encourage diversion of these hazardous electronic wastes to the existing special collection streams.**

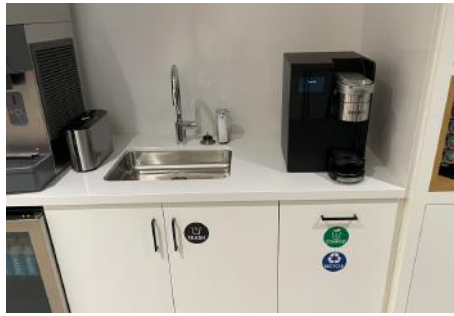
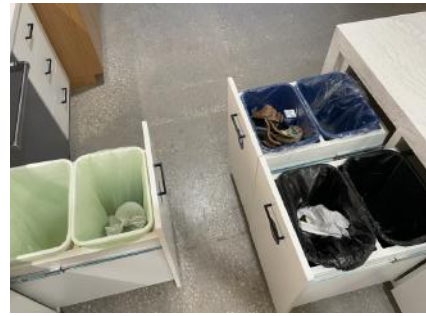
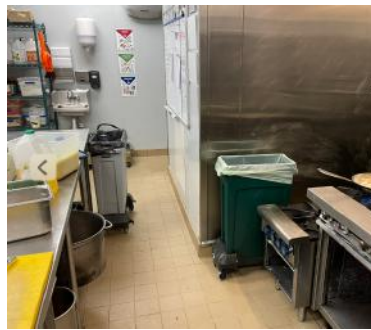
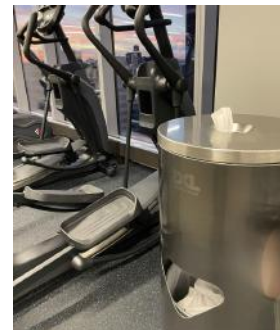
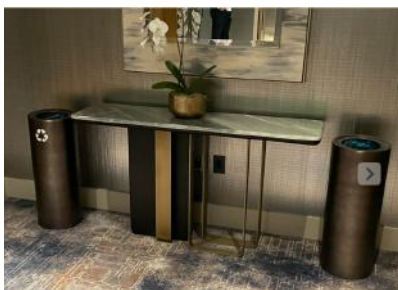
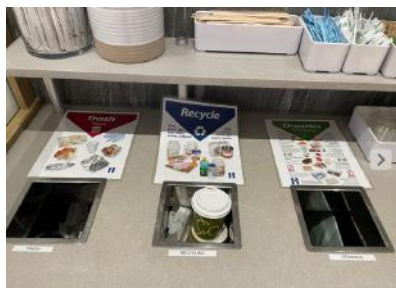
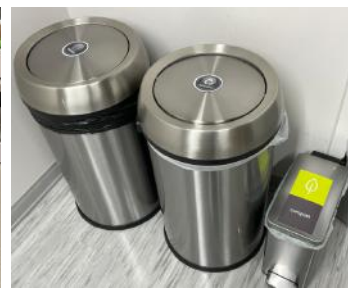
# A Closer Look: Systems & Sorting

- Floors inspected demonstrated adequate, and occasionally excellent, access to diversion bins. A **best practice is locating bins near workstation zones but not at individual desks.** When tenants have to walk to dispose of waste they are more likely to sort it correctly.
- **Floors 3, 9, 16, 17 & 20 should consider optimizing their bin strategies** to improve diversion.
- Most floors co-located recycle bins by copy machines, which is another best practice.
- **Correct bag usage was nearly universal, for which janitorial staff should be highly commended.**
- The combined bin in the top left picture is somewhat notorious for how long it takes to empty and reset. **Consider upgrading these units to systems that save valuable labor hours for janitorial.**
- Restaurants were doing an **excellent job locating rolling compost bins near food prep areas.**

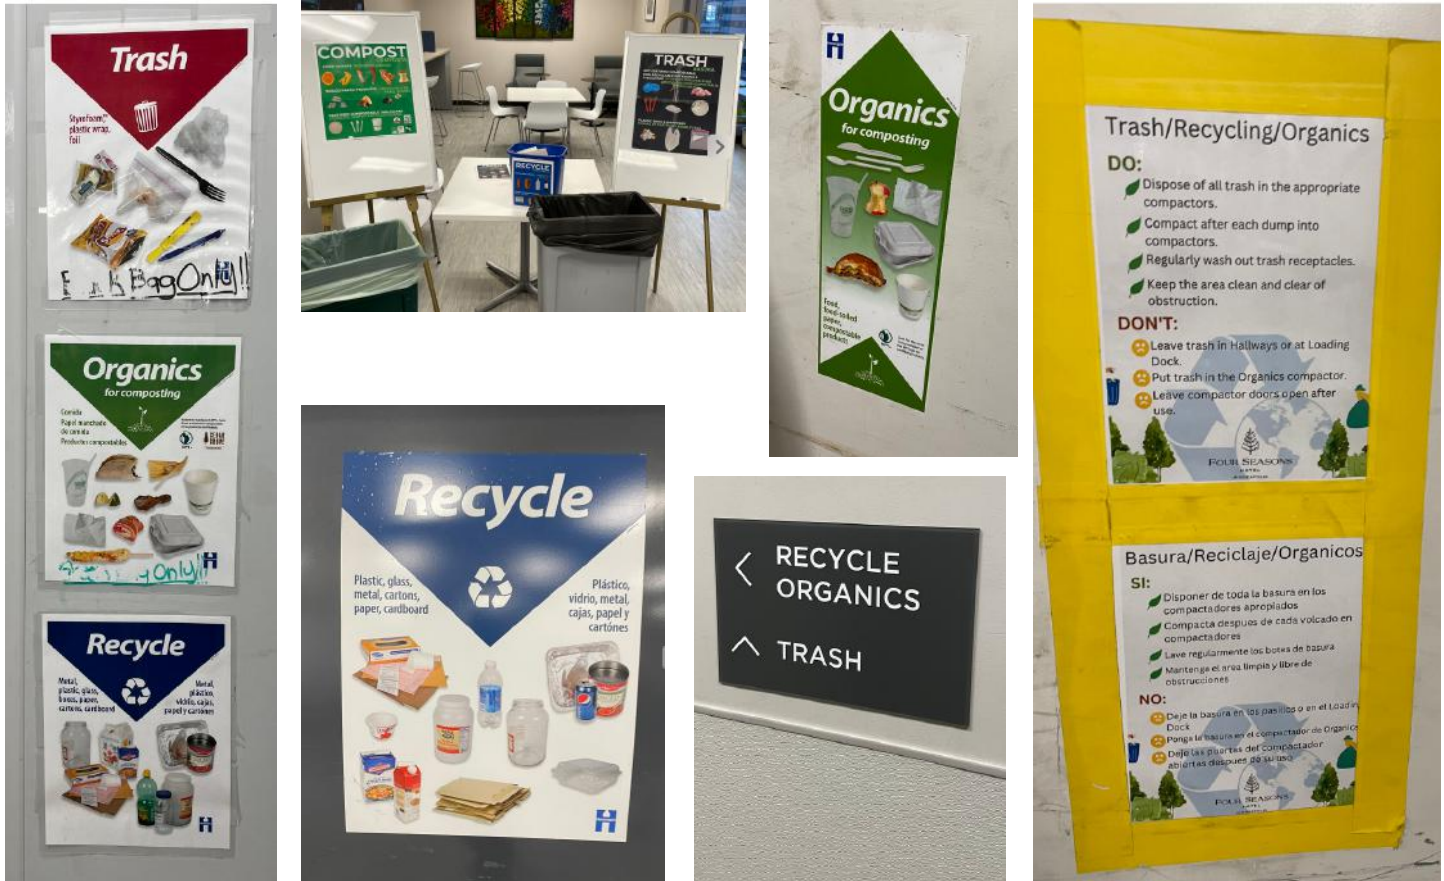
# A Closer Look: Audit Findings & Signage

- Signage throughout the building was very good, including visuals consistent and compliant with hauler policies demonstrating what is permitted in each stream.
- Management's inclusion of visual guidance on sorting in employee dining areas was uniquely exceptional.
- Wayfinding to trash and diversion containers is excellent as well.
- Bilingual signage elaborating on sorting policies with "Do/Don't" guidance offered excellent additional insight for building staff and undoubtedly have a great deal to do with the overall high rates of diversion and clean recycling on the hotel floors where employees are most likely to be complying with existing diversion policies when communicated well.
- Many office floors lacked thorough signage. We recommend a re-check for office floors to ensure signage that is up-to-date and highly visible on all office floors.

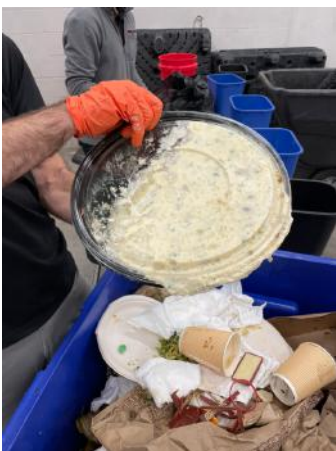
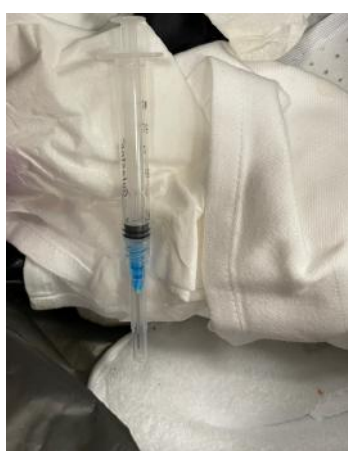
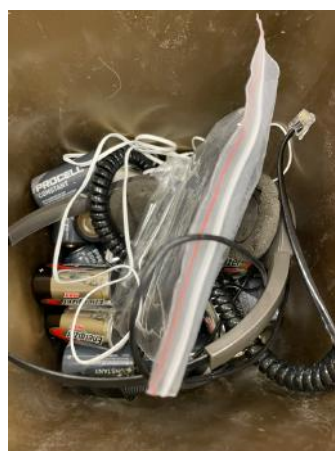
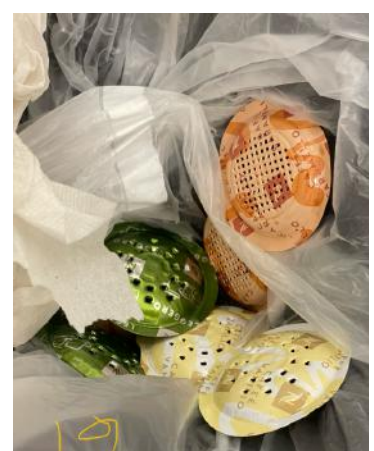
- Auditors did discover numerous recyclables contaminated with food waste and residues, rendering them unrecyclable. Remind tenants that, as a general rule, **if you wouldn't place the item as it is into an older home dishwasher, it's not yet clean enough to go into recycling. Take a moment to scrape food into trash/use a napkin to wipe it cleaner.**

- Plastic bottles with liquids must be emptied before placing in bins or they will be rejected by the recycling equipment at the sorting facility.
- Finally, **auditors were dismayed to discover substantial hazardous medical waste in hotel trash**, including multiple **hypodermic needles, blood-soaked gauze and prescription glass containers that require special disposal and handling.** The rising trend in use of injectable medications for weight loss and other medical treatments, in addition to the regular medical attention often required for professional athletes and other guests more likely to choose a high-quality accommodation such as this one, enhances our ongoing recommendation that **sharps disposal containers should be made available** in guest restrooms with special signage to indicate they are made available to better serve guests and ensure compliance with state laws forbidding sharps and medical waste in landfills. **At the very least, it is advised that some signage at check-in and special direct conversation for groups like pro athletic teams be considered, offering sharps disposal containers upon request.** The appearance of these hazards in building waste poses significant legal risk to the property, both from potential citation for illegal disposal as well as safety liabilities to employees and staff.

- These coffee pods are **recyclable only by special pickup** which is free from the manufacturer.
- E-Waste as seen below was minimal on all but a few floors.

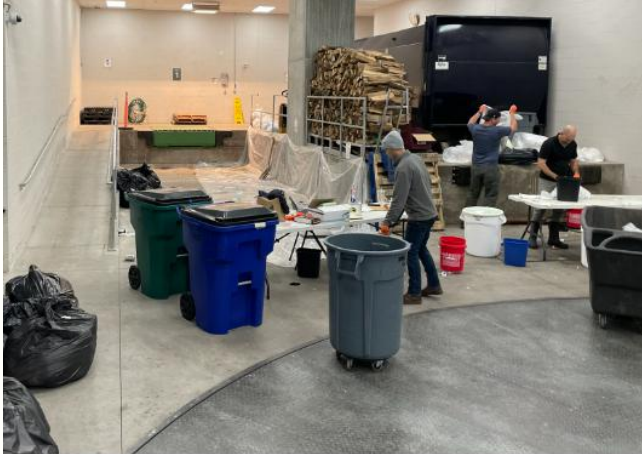
# Waste Stream Observations

- The tenants performed well in earning the building a high diversion rate of 72.9%. Compost made up 49% of the waste overall and was properly sorted at a rate of 83%.
- The hotel floors exhibited excellence in both signage and sorting accessibility. Waste and Compost bins on dollies are easily moved about to the points of waste generation.
- Contamination rates overall were exceptional with 17 floors logging contamination rates of 0%-0.3%. Floor 16 had the highest contamination rate at 25%.
- **Plastic was by far the most 'missed' recyclable**, representing the best target for improvement, as only 57% of it was correctly sorted for recycling.
- **As mentioned earlier, engaging residential units in greater diversion will be key to future improvement strategies.**
